Mock Inspection Report

508 Windsor Drive, Manchester, GA, USA

Oct 15, 2024

Performed by **Ronnie Watkins**

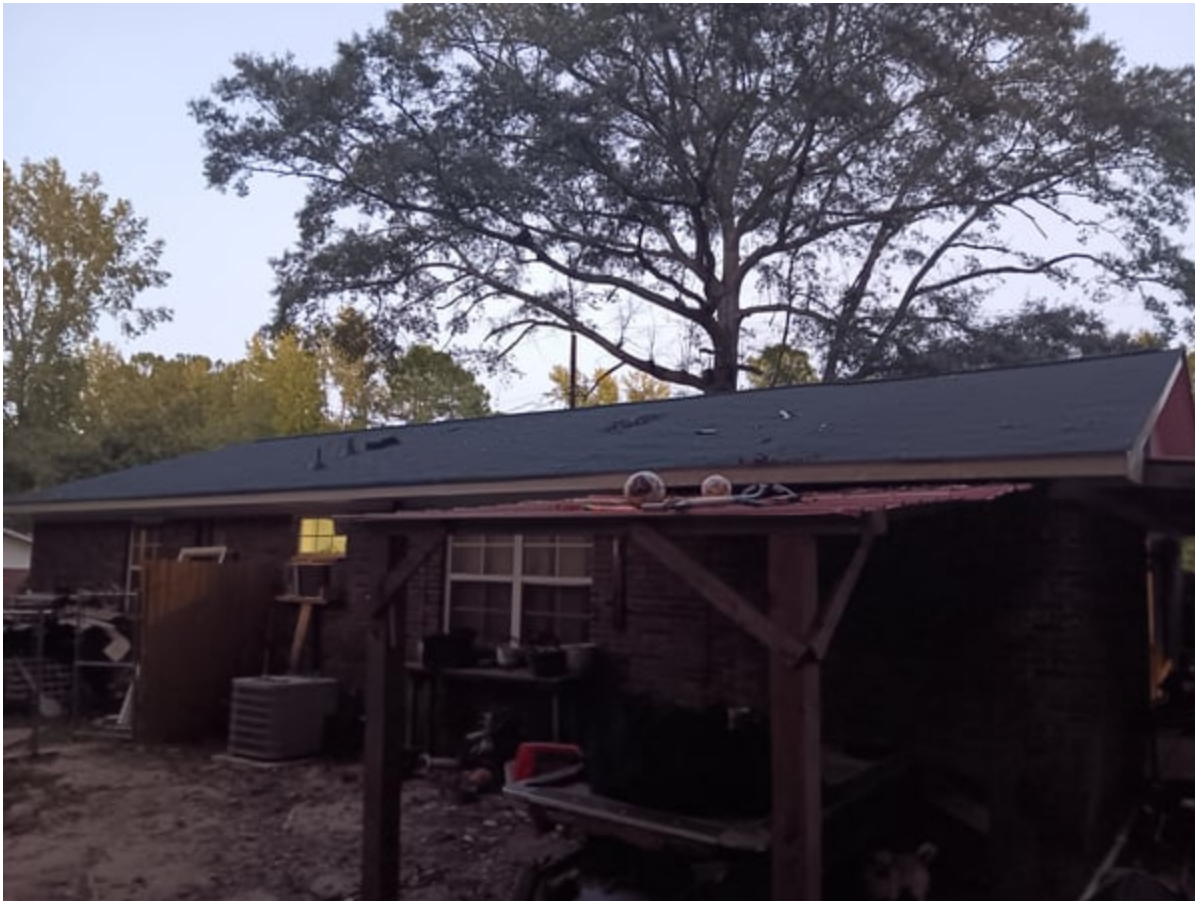
Vents, Flashing, Skylights, Chimney, and Other Roof Penetrations

No Defect(s) Observed

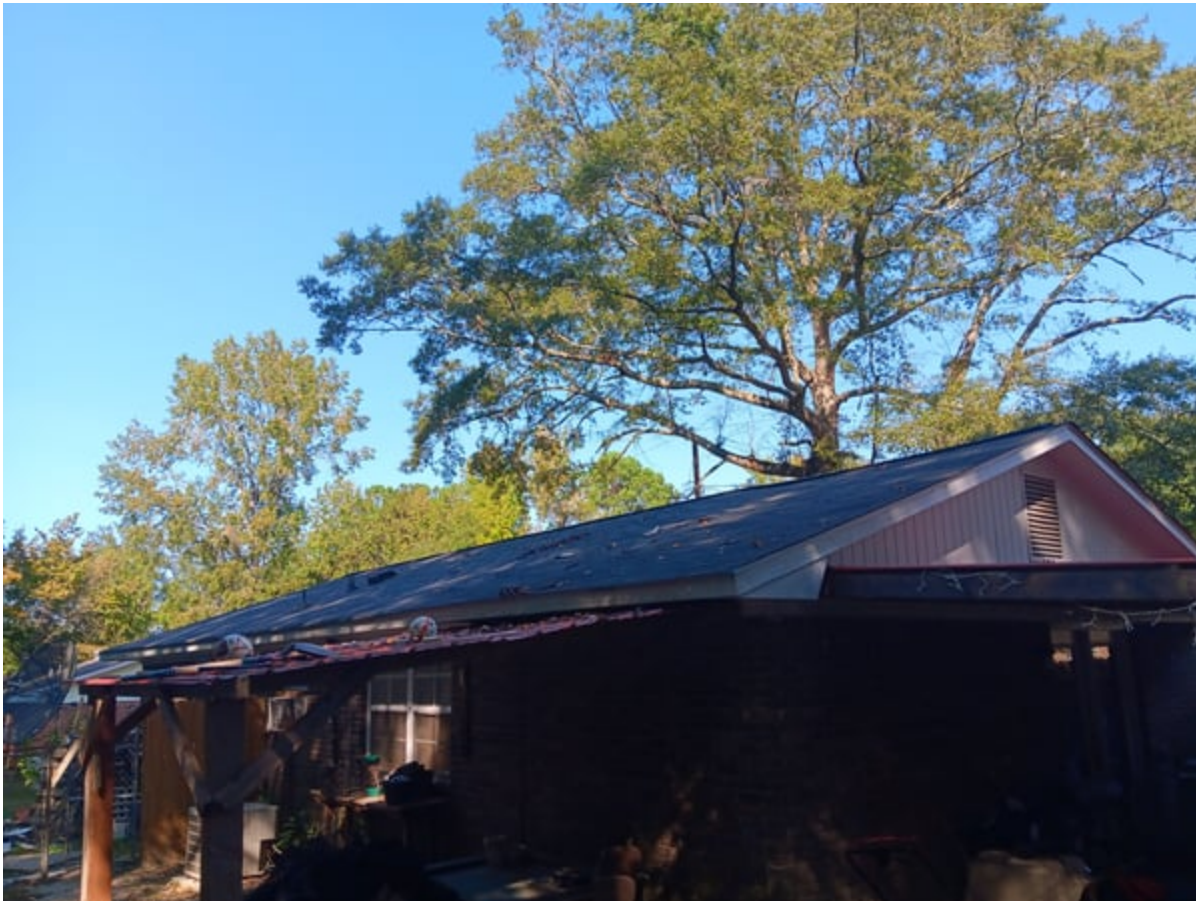
General Structure of the Roof (from the readily accessible panels, doors or stairs)

No Defect(s) Observed

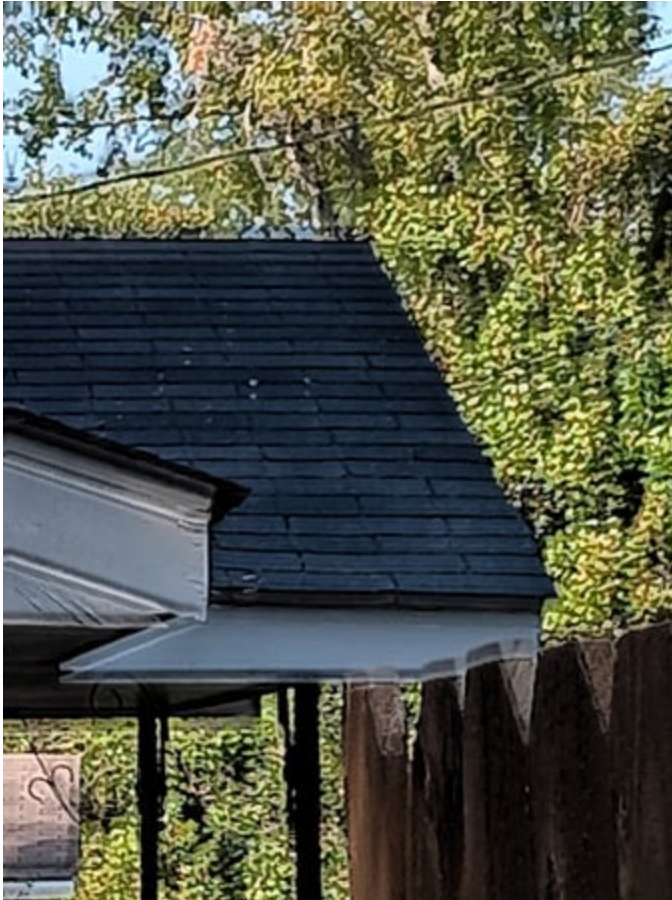
The Type of Roof-Covering Materials

- Asphalt Shingle

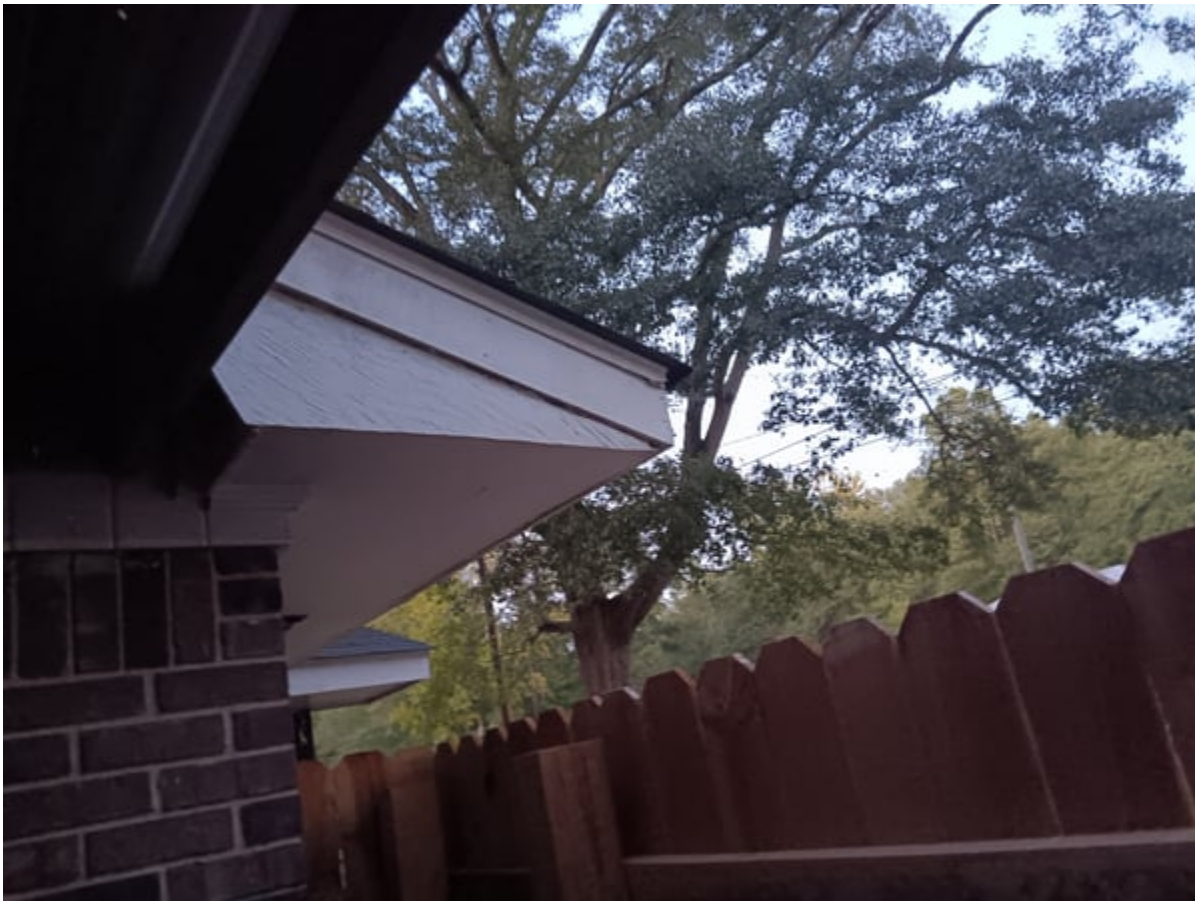
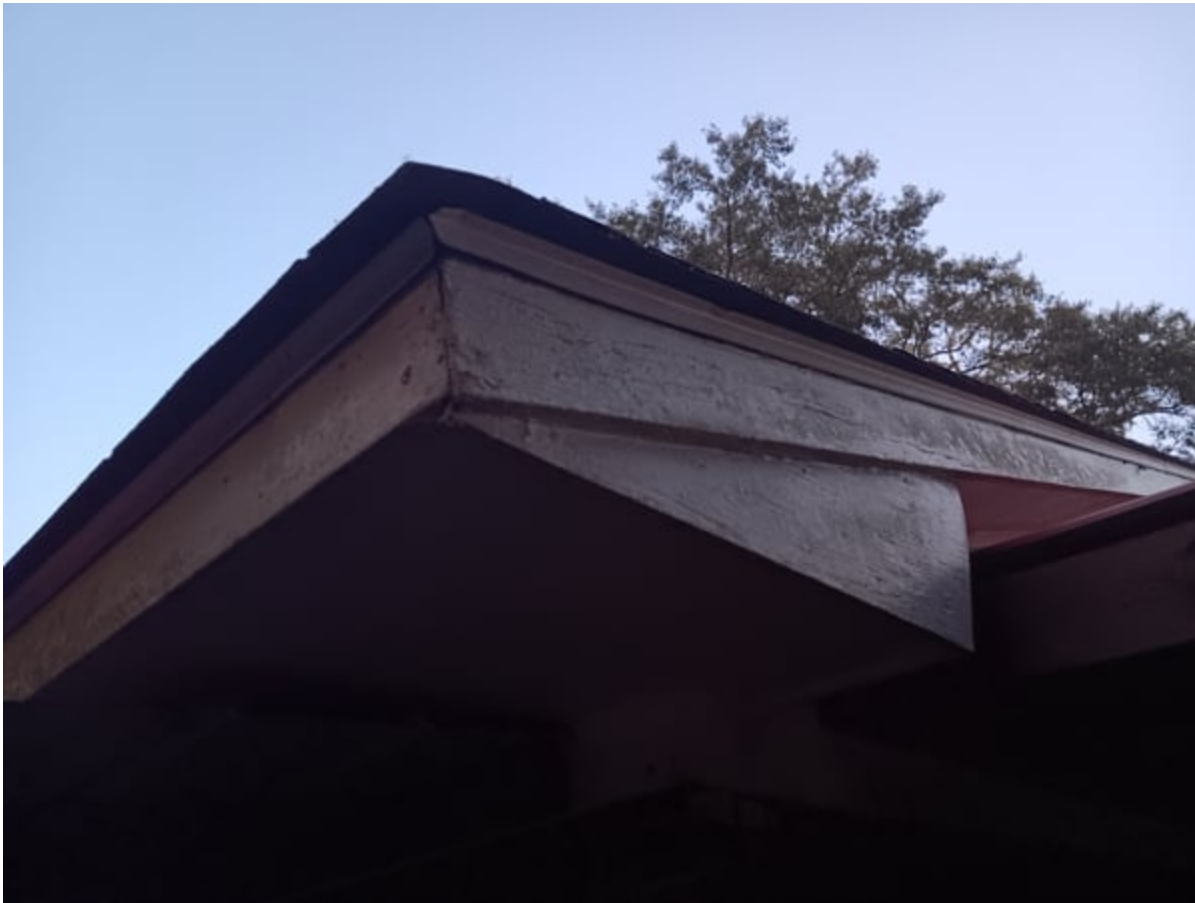
Eaves, Soffits and Fascia

Cosmetic Defect

In need of resealing and repainting to prevent decay from moisture intrusion

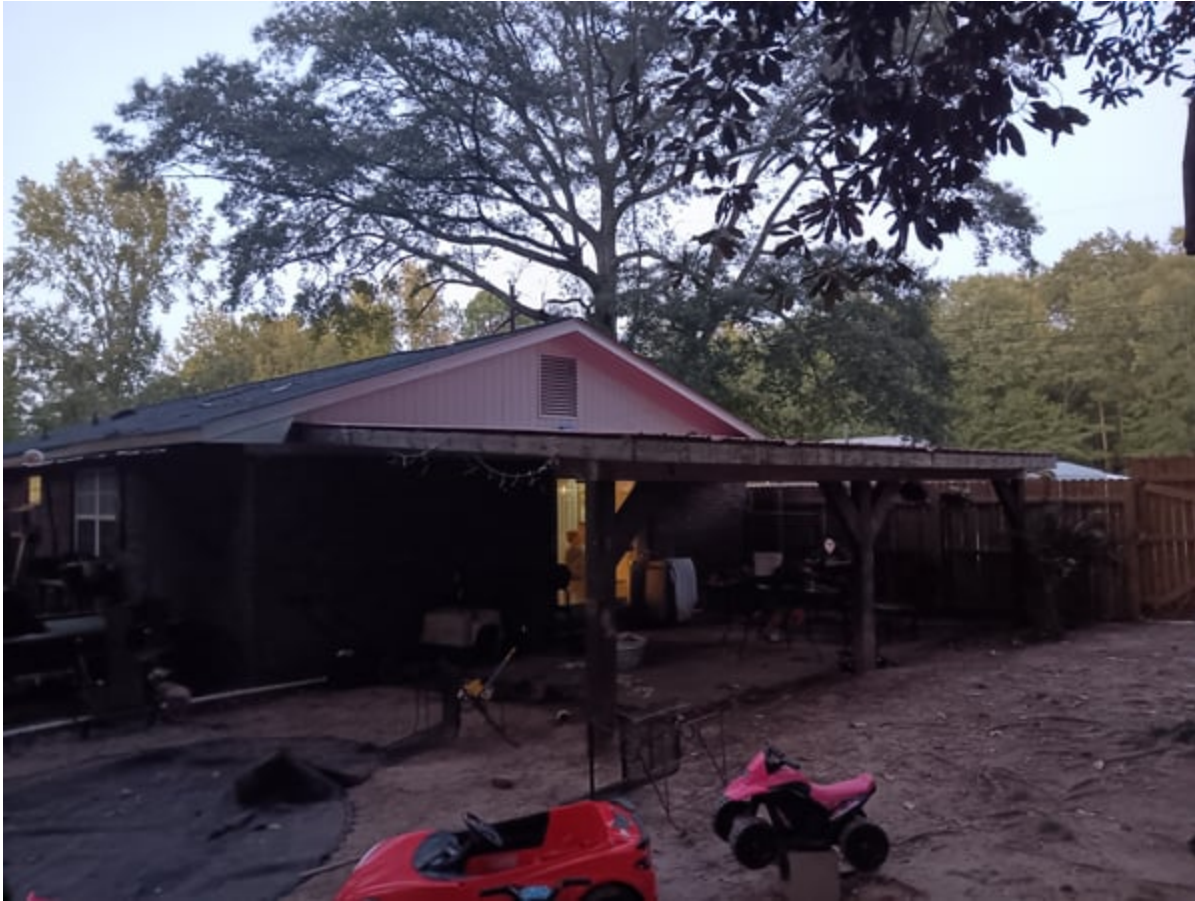
Structural Components

Major Defect

Multiple holes were noticed in the back patio roof top , I recommend adding additional 2×4 lumber under the roofing metal and on top of the rafters and insert metal roofing screws in all the exposed ,open holes

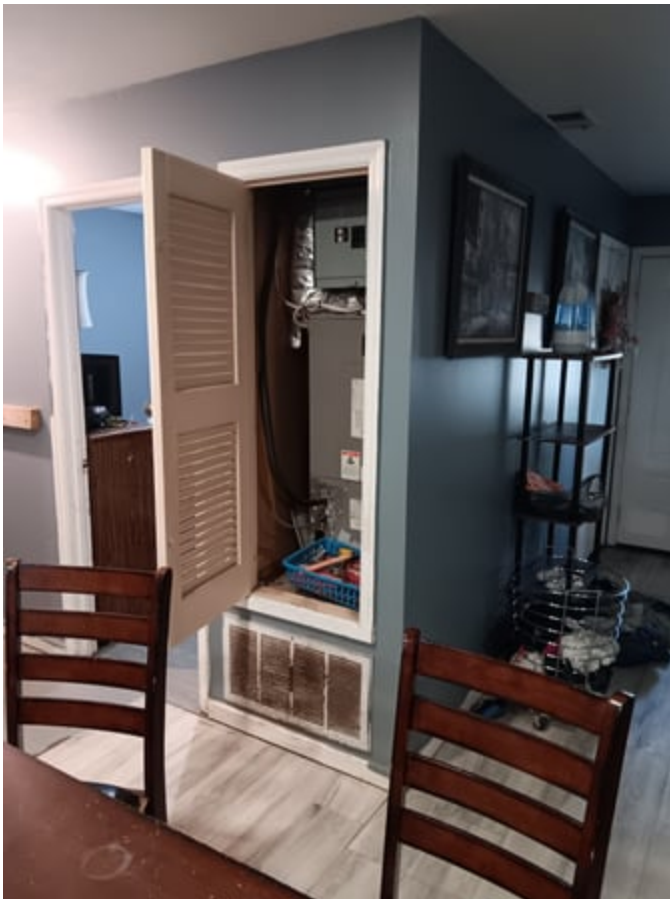
Location of the Thermostat for the Heating System

- At the entrance of the hallway
